Manhole Inspection Summary

Manhole # S63A__004MH

Insp Date: **5/22/08 1:49 PM**

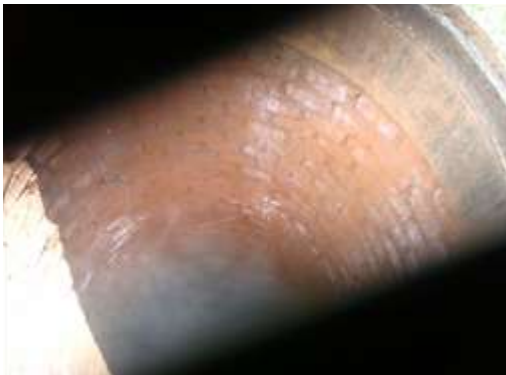
Defect 1

frame leaks

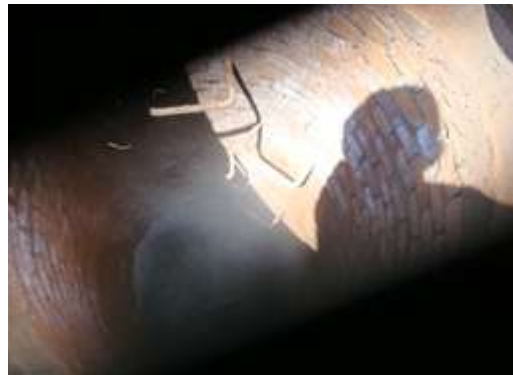
Defect 2

Infiltration: ☐ None ☒ **Joint** ☐ Cracks ☐ Mortar ☐ Roots ☐ Wall

Infiltration: ☐ None ☐ Joint ☐ Cracks ☐ Mortar ☐ Roots ☒ **Wall**

infiltration

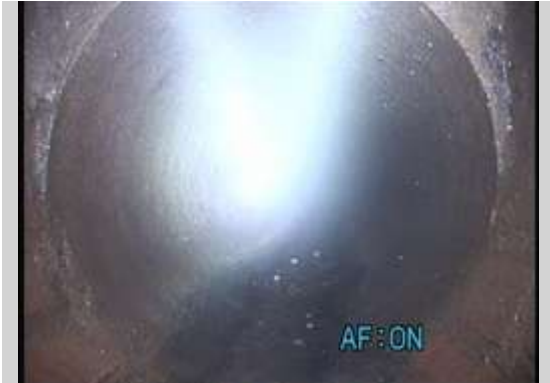
12 O'Clock Outflow

Pipe Height: **15.6** (in.) Rod and Bar (Angled)
Pipe Material: **Clay** ☐ Pipe Lined
Invert Depth: **20.35** (ft.) Flow Characteristics: **Fast**
Deposits: ☒ None ☐ Mud ☐ Sludge ☐ Debris ☐ Grease
Silt Depth: (in.) Deposits Extent:
Infiltration: **None** Pipe Seal Cond: **Sound**

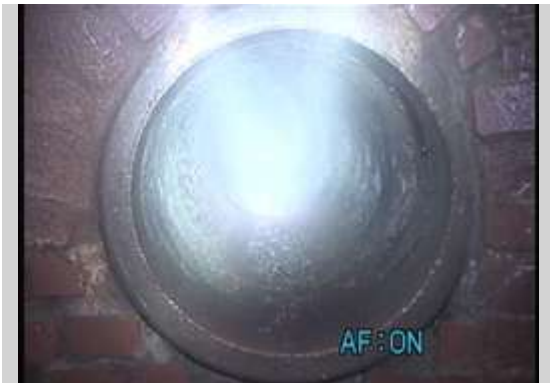
5 O'Clock Inflow

Pipe Height: **15.6** (in.) Rod and Bar (Angled)
Pipe Material: **Clay** ☐ Pipe Lined
Invert Depth: **17.10** (ft.) Flow Characteristics: **Fast**
Deposits: ☒ None ☐ Mud ☐ Sludge ☐ Debris ☐ Grease
Silt Depth: (in.) Deposits Extent:
Infiltration: **None** Pipe Seal Cond: **Sound**

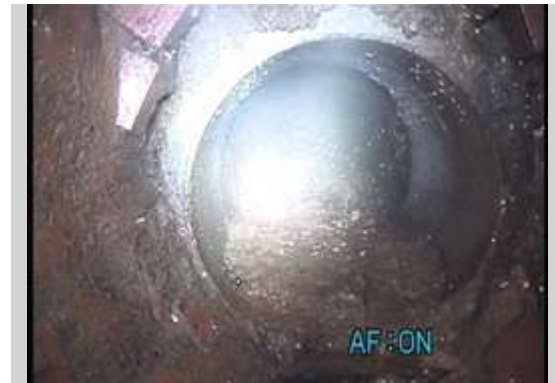
Drop In @ 5 O'Clock

Drop: **Inside** Rod and Bar
Angled: **Yes** Reading: **19.00** (ft.)
Inv Depth: **20.00** (ft.)
Drop Condition: **Open**

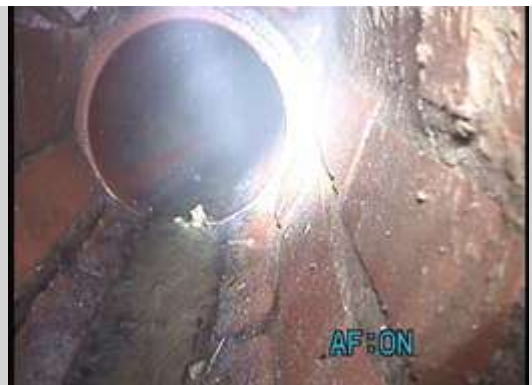
6 O'Clock Inflow

Infiltration: **None** Pipe Seal Cond: **Sound**
